XVIIth World Congress of the International Commission of Agricultural and Biosystems Engineering (CIGR)

FLUSH SYSTEMS FOR DAIRY MANURE REMOVAL: THE ALLEY ROUGHNESS VALUE

CSBE100442 – Presented at Section II: Farm Buildings, Equipment, Structures and Livestock Environment Conference

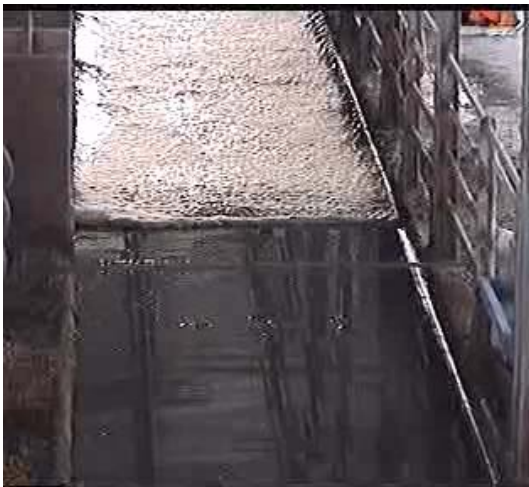
Figure 1. Flush wave on the clean freestall alley (barn 2).

Figures 1 and 2 show the movement of the flush wave on the freestall alley flooring, for the barn 2. It clearly appears how the front wave is moving regularly on the clean floor compared with the wave flow along the dirty floor of the alleys. The roughness obtained values justify this behavior.

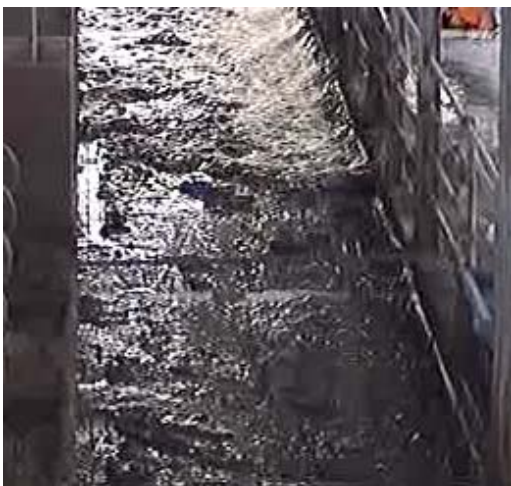
Figure 2. Flush wave on the dirty freestall alley (barn 2).

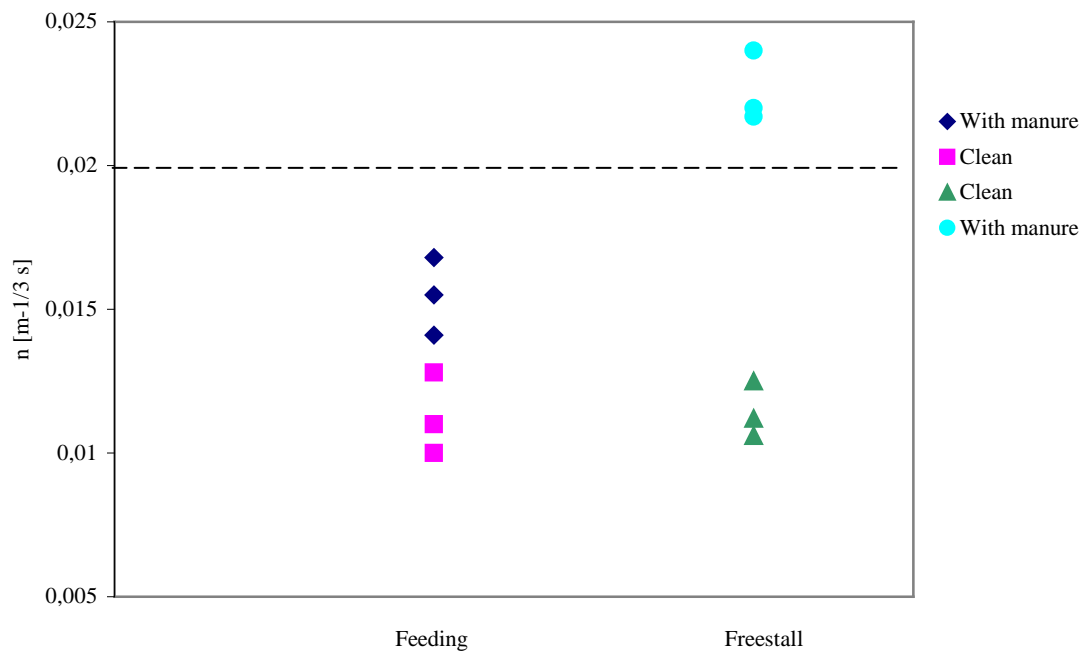
Figure 3. Manning coefficient (n) for the different alleys under normal and clean conditions for the freestall barn 1 (dash line represents the n value equal to 0.02 as suggested in literature).

RESULTS AND DISCUSSION The values of the Manning coefficient n are obtained from the Chezy formula substituting the measured velocity and the surveyed flow depth for each trial. Data elaboration has been made both separately for each freestall barn and then grouped for alley type. The barn 1 and 2 have in fact the same alley grooves. In figure 3, n values for the barn 1 are shown, with the reference value of 0.02 as suggested in literature, separated between feeding and freestall alley types. The repeated trials on the clean alley of both types show comparable values included in the interval 0.010-0.013, thus a value of 0.01 (cut at the third digit) may be considered as the typical roughness number for an alley made of concrete with longitudinal grooves, 0.02 m wide and deep and 0.1 m spaced. As regards the feeding alley, the range is 0.014-0.017, showing an increase of 27% compared with the n value for the clean alley. The freestall alley presents values in the interval 0.022-0.024, showing an increase of 46% compared with n value for the clean alley. The higher value calculated for the freestall alley, compared with the value obtained for the feeding alley, may be justified by the presence on the alley of both manure and litter material. From the graph, it is clear how all the values are under the 0.02 line with the exception of values for the freestall alley.

With reference to the barn 2, the roughness values for the clean alleys are 0.012 and 0.011, confirming the previous values calculated for the alleys of barn 1, presenting similar groove type. For the freestall alley, the obtained n value is 0.018 representing an increase of 39% with respect to the clean situation. This percentage is lower than that one obtained for the same type of alley of barn 1, but it may be justified by considering that the presence of litter (type and quantity) influences the roughness. In barn 2, the feeding alley presents some differences in comparison with barn 1 as it is wider (4.2 vs 3.3 m) and gives access to a single row of freestalls. The obtained value for the roughness is equal to 0.027, showing an increase of 52% with reference to the clean value. It is obvious that this value cannot be compared with any other among those belonging to the other freestall barns. It can be observed that this roughness value is the maximum obtained and it may be justified by the fact that the amount of manure present will be greater. As regards the barn 3, the 0.017 n value for the feeding alley is comparable with the previous ones.

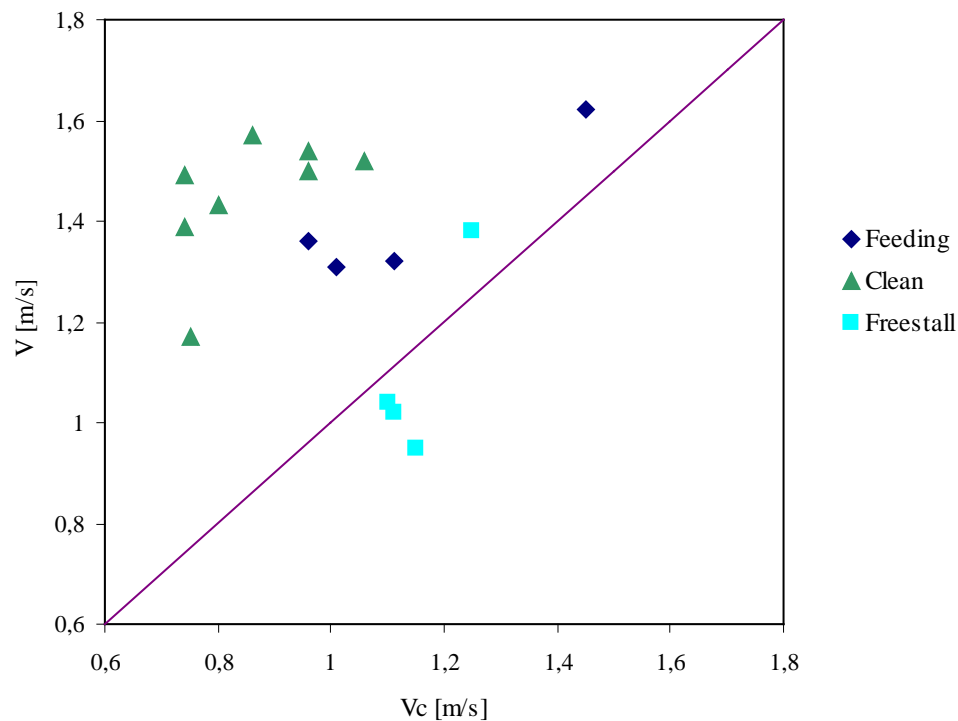
Figure 4. Measured velocities (V) and calculated velocities (Vc) for different alleys.

In figure 4, the velocity values, calculated with the Chezy formula using a n value equal to 0.02 and the measured ones, are reported for all the investigated barns. Points close or on the straight line are those whose calculated and measured velocity values are similar, resulting in n values close or equal to 0.02. All the points are above the line with the exception of those corresponding to the freestall alley for barn 1. For those points, the n value equal to 0.02 would result into a weak over estimation of the velocity. The value of n equal to 0.02 may be considered representative for a situation which is not the current one in the surveyed barns. The only point belonging to the freestall alley over the straight line is for the barn 2 and this may be justified by observing that the freestall alley may be strongly influenced by the litter type and quantity. In this case, the obtained n value is less than 0.02. For the other freestall points, the obtained n value is bigger than 0.02.

As regards the feeding alley, it clearly appears that the n value equal to 0.02 involves an under-estimation of the velocity value. The value far from the other three corresponds to the barn 3, which was characterized by a different type of grooves compared to the other two, thus influencing the roughness value both for the clean and the dirty conditions.

As regards the clean alley case, all the points are far from the line resulting in higher measured velocity than those calculated with the 0.02 n value. The under estimation may be strong for this situation and n value equal to 0.02 is too high for that situation.
